# **The Lavaca Neighborhood Design Guidelines**

**San Antonio, Texas**

Written and Illustrated by: Sue Ann Pemberton-Haugh, AIA  
Mainstreet Architects Inc.

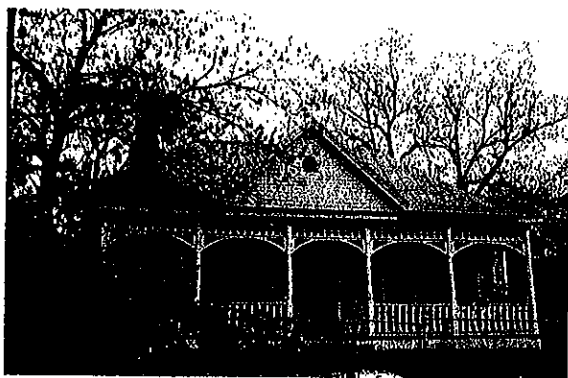
*Many of the roofs are covered in standing seam metal.*

- Roof material - Many roofs are covered with metal, whether standing seam, pressed shingle or V-Crimp. Some of the metal is installed over wood shingle. Some composition shingle roofing has replaced various materials such as wood shingle or standing seam metal.

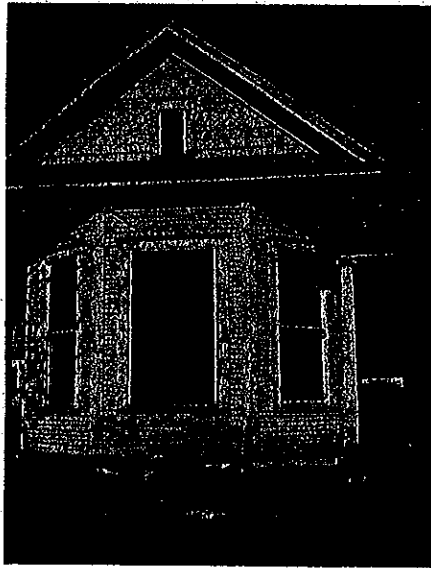
*Cedar post foundations are common to wood frame structures.*

The majority of houses in the Lavaca Neighborhood are of frame construction with foundations consisting of cedar posts set into the ground. This type of construction raises the house above the ground and the space between house and ground is closed in with a wood "skirt". The posts have a tendency to fail over time causing the house to shift. The skirts also deteriorate over time. The best method to repair the foundation is to install new posts of cedar or chemically treated wood. This allows for leveling of floors and the addition of extra supports if needed.

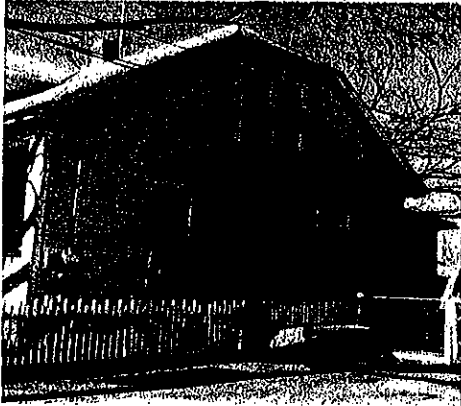
*Deteriorated paint on wood siding should be properly removed during rehabilitation. The siding can then be primed and repainted for added life.*

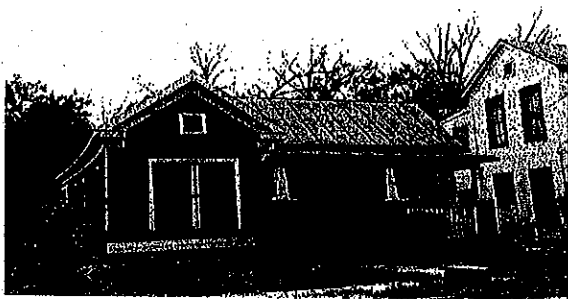
*This existing synthetic siding could be removed and the wood siding beneath it could be restored.*

1. Remove existing synthetic siding and repair original siding and trim underneath.
2. If existing synthetic siding is in good repair and does not obliterate all original detail, consider retaining the synthetic siding. If original detail is concealed by the synthetic material, consider removing that material which covers the detail or reinstall trim and detail that has been removed. For example, reinstall corner boards that were removed when asbestos siding was installed.
3. If the synthetic siding is badly damaged or it is cost prohibitive to restore the original siding, consider removing the siding and replacing it with an alternative material of the same dimension and profile. Alternative sidings might include such products as cement board siding, or other board siding, etc.

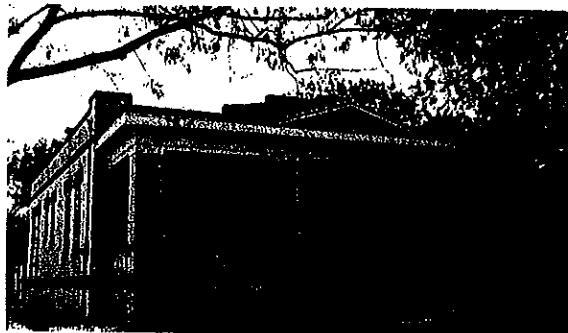
*Brick wall surfaces should have deteriorated mortar replaced to keep moisture from entering the wall.*

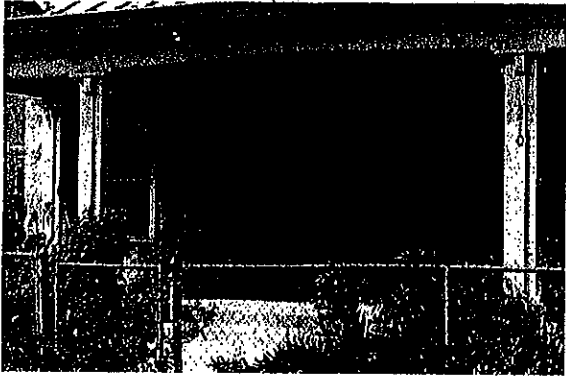
*The soft caliche stone should be covered with a soft lime plaster to protect it.*

Limestone and caliche block houses in Lavaca were historically covered with a soft lime plaster to protect the soft stone from deterioration. Some of these houses have been covered with a modern portland cement plaster which is detrimental to the stone. This portland cement plaster should be removed and replaced with soft lime plaster if applied over caliche. The harder limestone structures may not require the plaster coating.

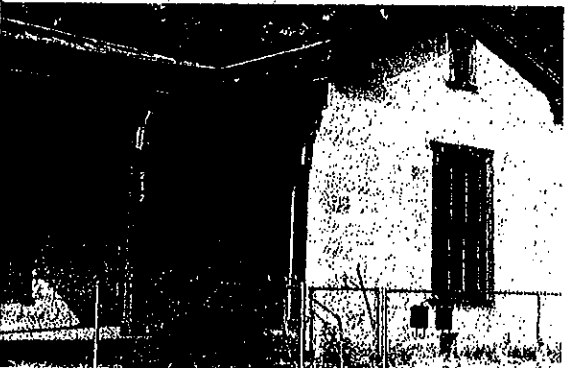
*This limestone house requires no plaster coating.*

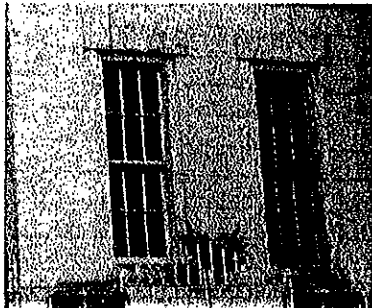
*This 6 over 6 true divided light sash is important to the period of the house.*

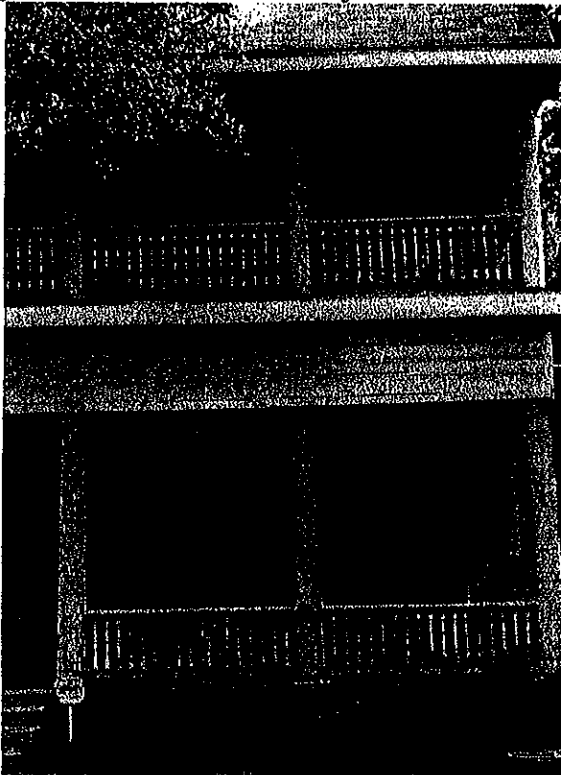
*Retain and repair turned wood railings, columns and porch deck.*

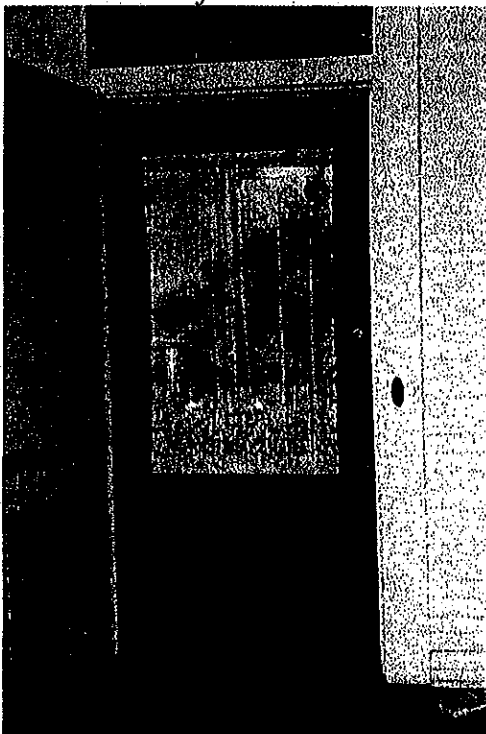
*This is a typical historic front door with the upper glass panel, wood screen door and transom.*

The houses of Lavaca have a wide range of entry treatments corresponding to the variety of housing styles. Even the simplest of houses have a well defined entry. Many of the houses have multiple entrances and most house have transoms, frequently with side lights. Historic front doors usually have glass upper panels and should be repaired if at all possible. In cases where doors are damaged beyond repair or are completely missing, a salvaged door may be appropriate. A new entry with a simple but compatible design may be an acceptable solution. Another important feature is the wooden screen door, often with decorative inserts which is present on most houses. Screen doors should be repaired when possible or replaced with new wooden screen doors which have wider stiles and rails than their contemporary aluminum counterparts. If a full panel aluminum storm/screen door is the only affordable solution, a baked-on painted finish is more appropriate than a shiny aluminum "mill" finish.

It is important to maintain the multiple components of the entry doors, including glass panel doors, transoms, sidelights and screen doors. Transoms have often been boarded up rather than repaired. In the case where synthetic siding has been installed the transoms are frequently covered over. Covering a transom distorts the strong vertical proportions of the windows and doors.

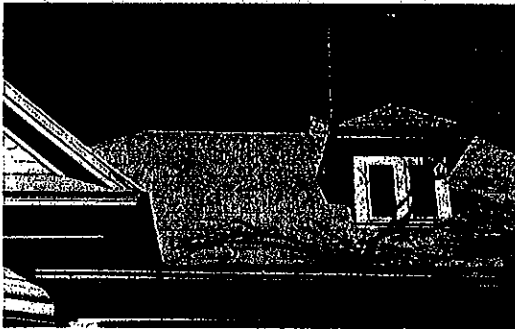
*This house is covered in pressed metal "fish-scale" shingles.*

Pressed metal shingles give a unique dimension to the roof of a structure and if maintained, have a life of 60 or more years. New metal shingles are still available in the same profile as historic shingles if replacements are needed. Another alternative is to salvage metal shingles and reinstall them on the primary facades, and use an alternative material, "V-crimp," on less visible roof surfaces.

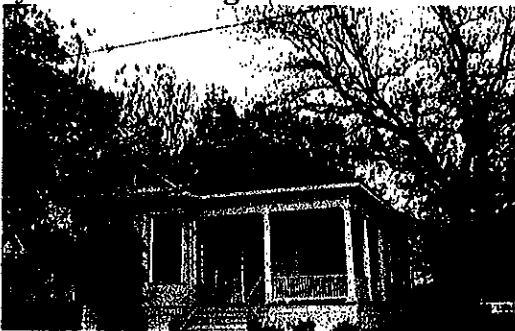
*Standing seam metal roofs are common to the neighborhood and last for decades if properly maintained.*

The Lavaca neighborhood is dominated by standing seam metal roofs with a few pressed metal shingles, a few wood shingles and of course composition shingle roofs. The standing seam metal roof adds a very distinctive vertical line to the roof of the house. Metal roofs are usually painted with a lead based paint and should be repainted to encapsulate the toxic lead paint. The condition of the paint and the future regulations regarding lead paint and its removal will be discussed at a later date as regulations are finalized.

Standing seam metal was often an early replacement for wood shingles and was installed directly over the wood shingle. If the metal roofing were to be removed and replaced with an alternative material it must be noted that a solid wood deck should be installed prior to new shingles. The composition shingle is currently the most common replacement material but another replacement option is "V-crimp" metal which is more similar to the appearance of standing seam metal. Multiple chimneys and dormers are also prominent features which add character and date the house. Dormers and vents are often neglected and dormer windows broken, allowing birds to nest in attics and rain to enter. Dormers, chimneys and vents should be retained, repaired and new flashing installed if necessary.

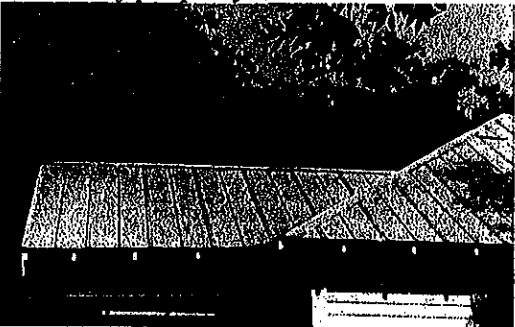
*"V-crimp" metal roofing is an affordable alternative to composition shingle or a new standing seam roof.*

3. If repair or replacement of a metal roof with an exact match is cost prohibitive, consider replacing the deteriorated material with an alternative replacement such as "V-Crimp" metal roofing or composition shingle.

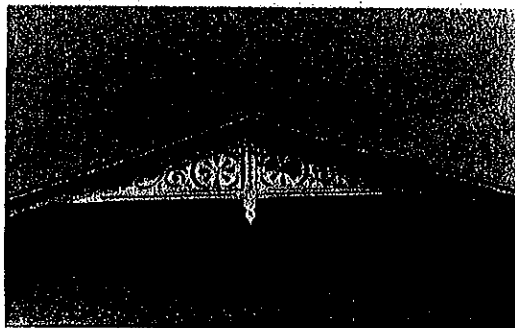
*This scroll cut bargeboard decorates the gable end of this roof.*

Roof edges and front facing gable ends are normally an area for decorative features on the houses of Lavaca. Gable ends frequently have shingled wall surfaces with decorative vents or windows and decorative barge boards. Frequently the triangle of a gable end is completed by a small portion of roofing which should be treated as roofing. Boxed eaves are sometimes accentuated with dentils and brackets or consoles. These features are important to the period of the houses whether Victorian, Classical or Craftsman. These details are also prone to damage and deterioration if a structure is not maintained.

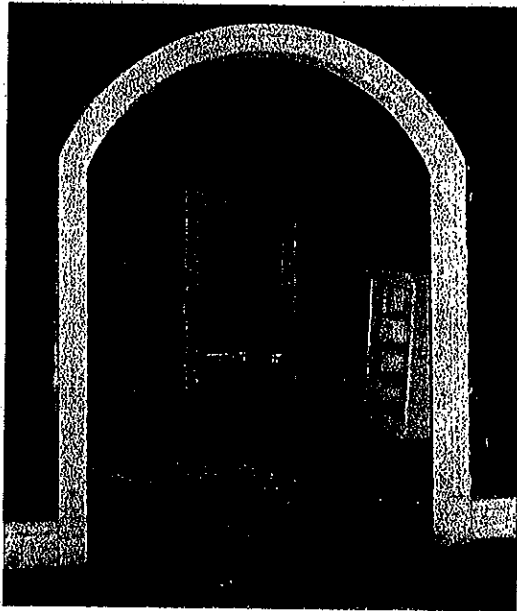
*Wood floors, deep base moldings and arched openings are some of the interior features that should be retained during the rehabilitation of a house. The interior walls of this house have solid wood sheathing.*

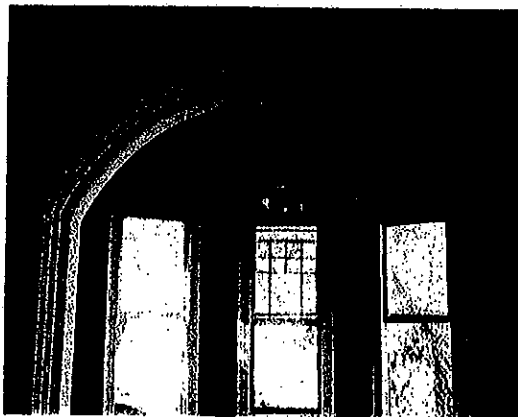
*Solid wood walls and ceilings were originally covered with cheesecloth and wallpaper.*

Walls and ceilings play an important role in the visual appearance of the interior of a house. The type of construction found in Lavaca provides three different kinds of wall finish. The limestone and caliche block houses have plaster directly applied to the inside surface of the stone. Frame construction sometimes utilized the traditional wood lath and plaster finishing system, but more frequently, a solid wood ship lap was installed over the studs, and cheesecloth and wallpaper were applied over the wood.

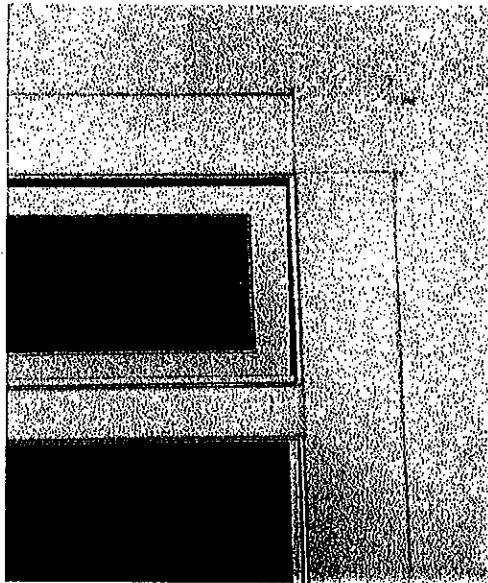
*Interior transoms and corner blocks add to the character of the interior spaces.*

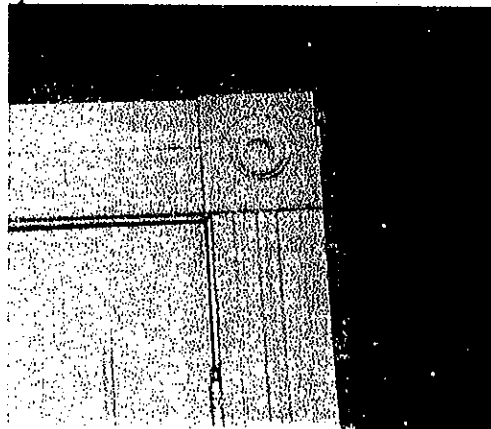
*This "bulls eye" corner block and carved wood trim should be retained and repaired.*

**Corner Block** - a square block used to trim casing at the upper corners of door or window surrounds; typically decorated with a milled bull's eye, known as rosettes

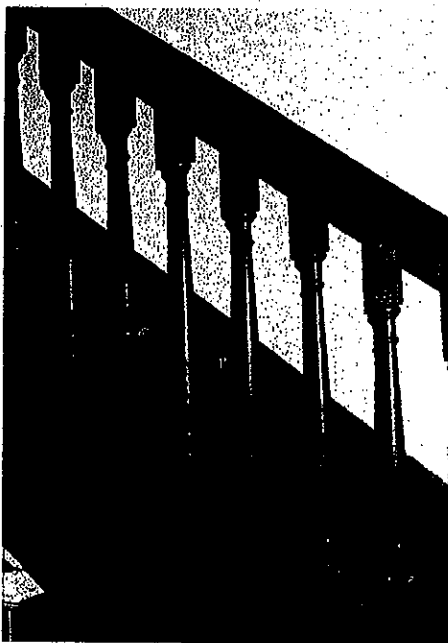
*This staircase has turned wood spindles which are common details in houses large and small.*

A few of the houses are two-story and the staircases and railings are an important part of the design. If a few pieces of the railing are missing it is worth having them milled to match. If "one of a kind" pieces such as newel posts are missing, consider constructing a new post in a simpler design that is compatible with the original.

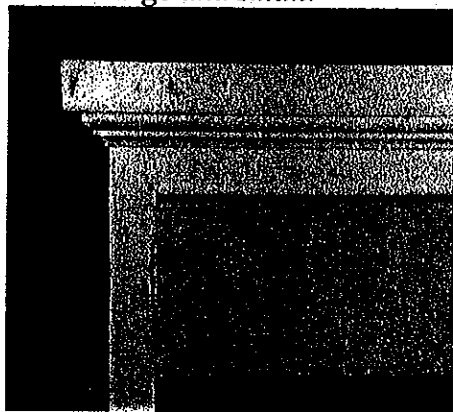
*This modest built-in cabinetry is useful and appealing. The doors are missing but were probably wood frame with glass panels.*

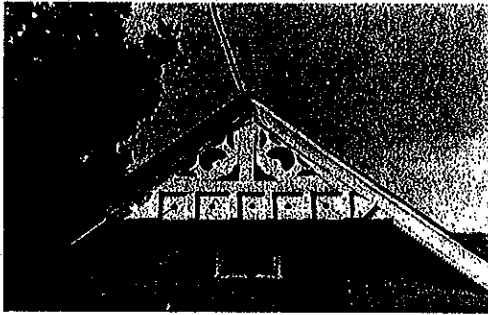
*A decorative bargeboard appears on a gable end.*

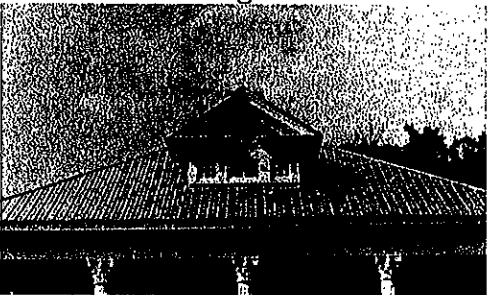
*Capitals sit on top of columns and support the roof. The dormer projects above the roof the metal roof.*

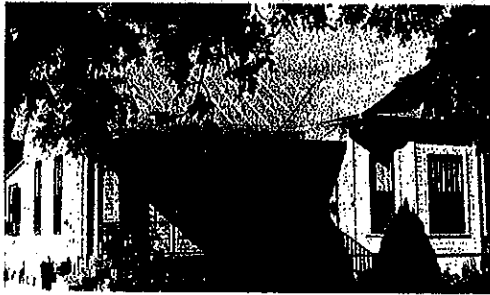
*This house has fabricated metal porch columns and railings.*

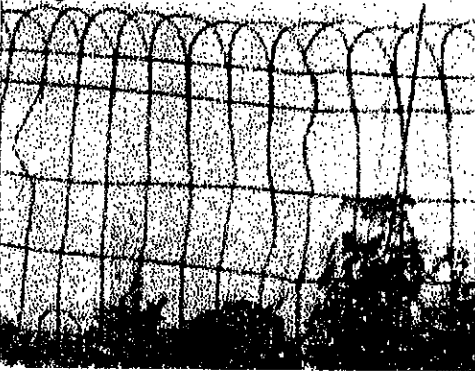
*Garden loop wire fence is an appropriate alternative to non-historic chain link fencing.*

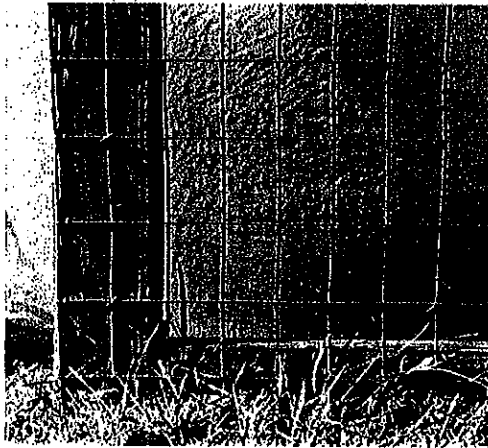
*Welded wire fence called "hog wire" is an appropriate alternative to chain link.*
